Allegheny Portage Railroad

New Support for Old Arches

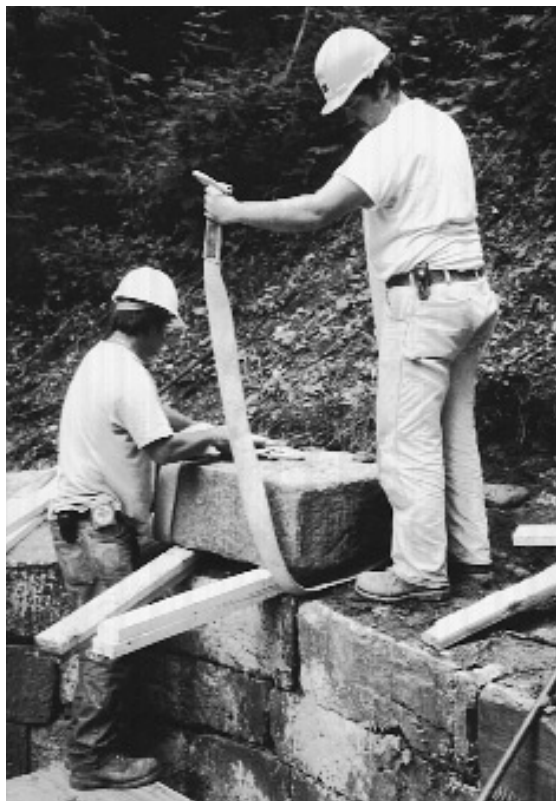
Dismantling process—coping course, culvert 1733.

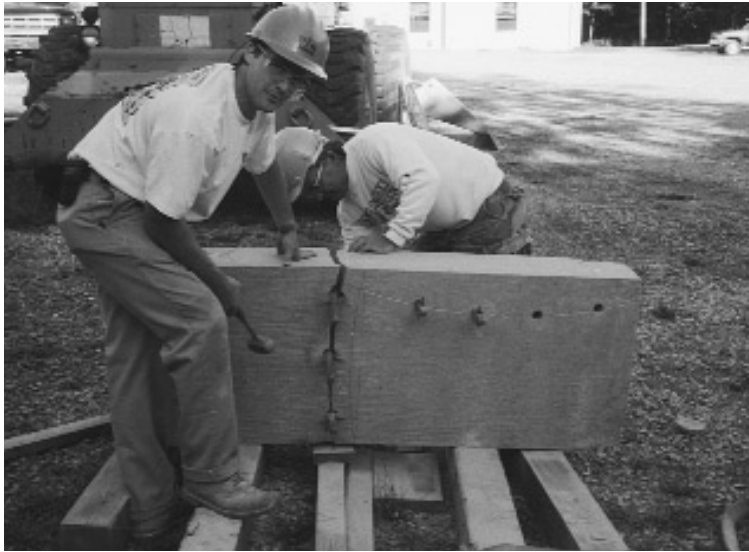
Splitting sandstone slabs for culvert 1656 using feathers and wedges.

A short assignment of using traditional feather and wedge tools to cut the large slabs into individual stones demonstrated to the HPTC crew the labor-intensive and often frustrating methods their 19th-century counterparts likely used. For the most part, however, the stones were cut using a gas powered masonry saw outfitted with a dry cut diamond blade, then split using wedges from the feather and wedge sets.

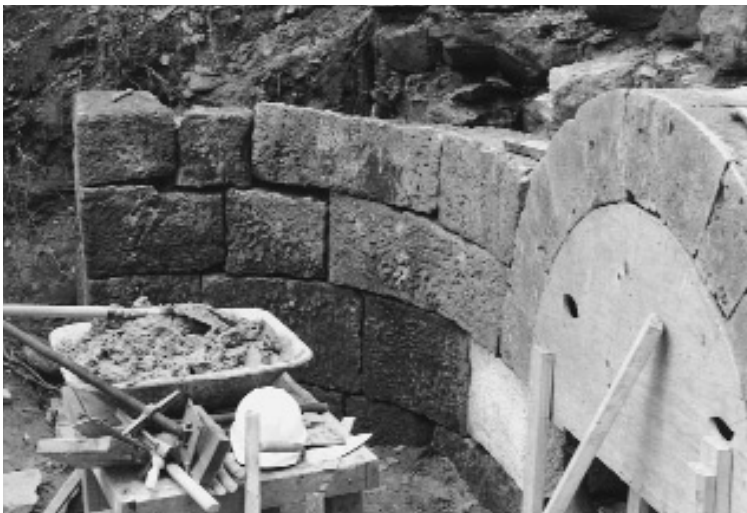
Dismantled culvert—backer wall exposed, culvert 1733.
